# **BACTERIOGENICALLY INDUCED SULFURIC ACID ATTACK ON CONCRETE IN AN AUSTRIAN SEWER SYSTEM**

Master thesis

**Cyrill Grengg, BSc**

**Technical University Graz**

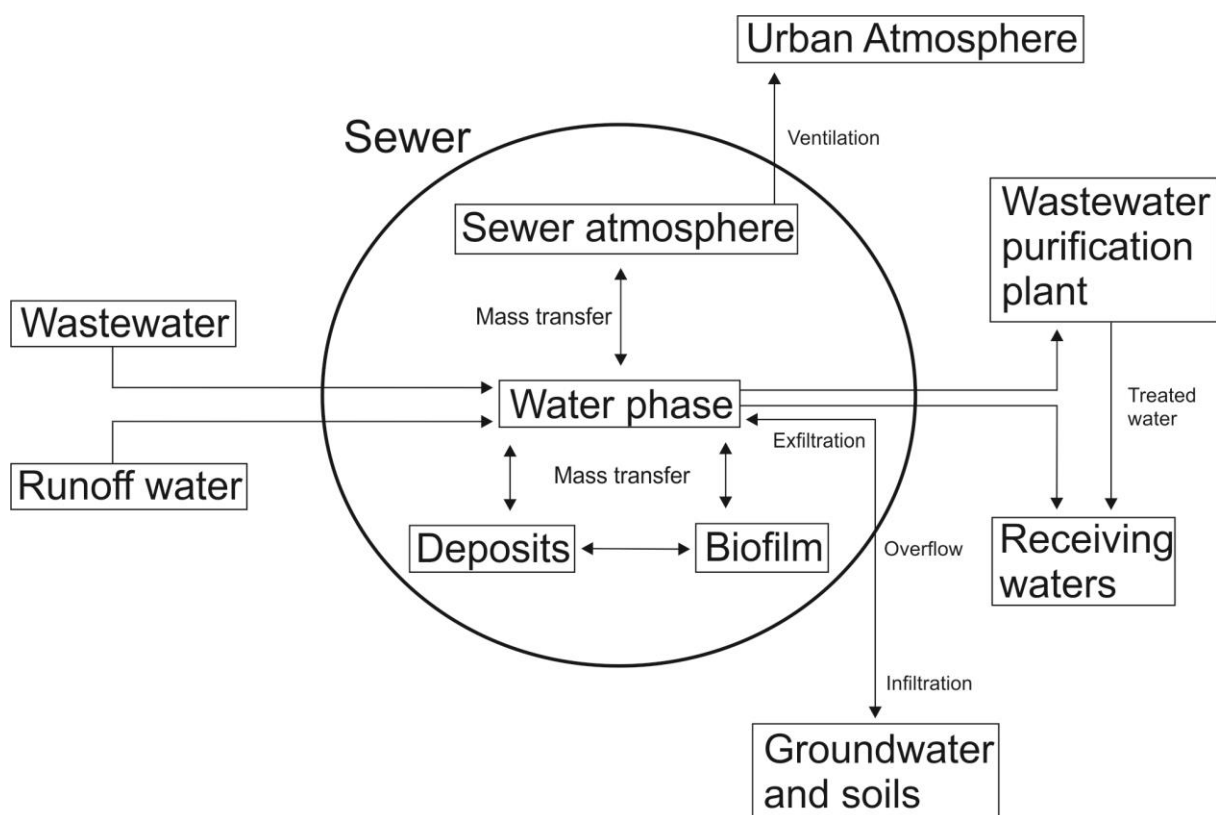
**Figure 1: Schematic illustration of interaction between the five phases present within a sewer system. Arrows indicate the possible mass transfer between the phases present within the sewer and its receiving surrounding environments (modified after [2]).**

**Figure 1** Figure 1 illustrates the dynamic interaction between the sewer phases and their receiving surrounding environments.

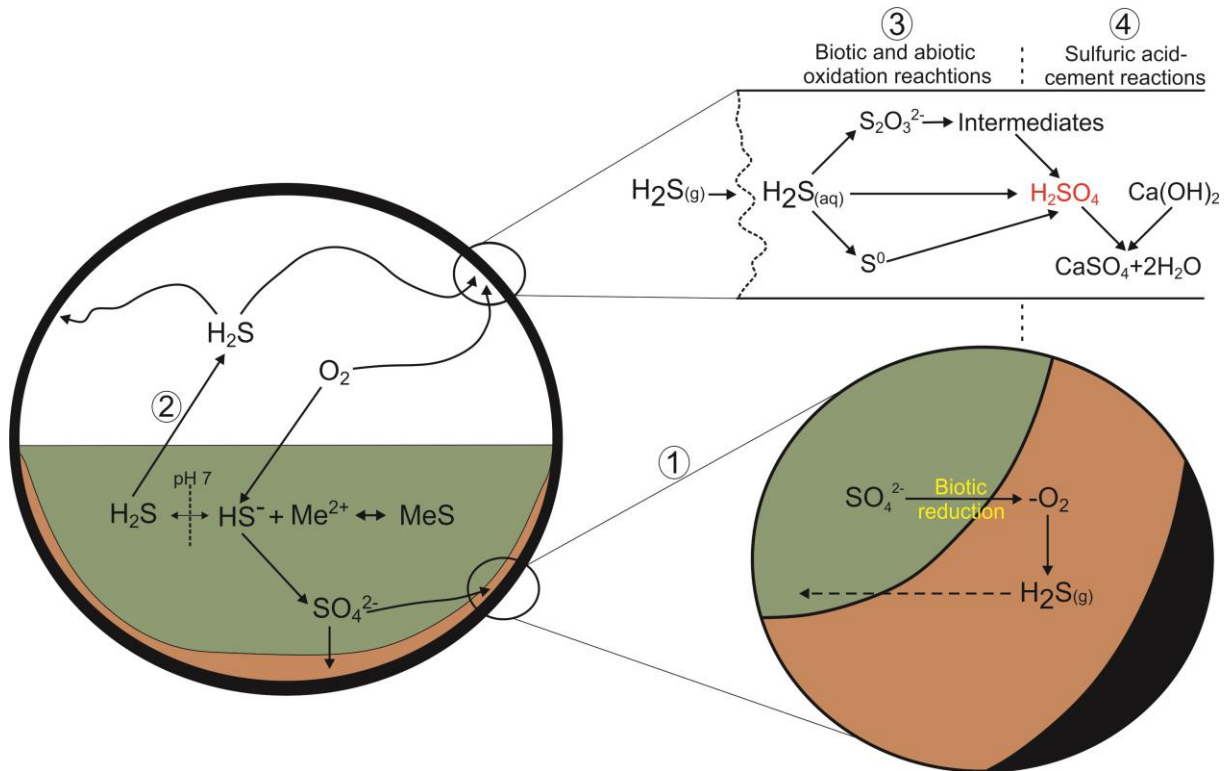
**Figure 2: The sulfur cycle within sewer systems. Initial reduction of sulfate ( $\text{SO}_4^{2-}$ ) occurs within the anaerobic biofilm producing  $\text{H}_2\text{S}$  (1), followed by degassing into the sewer atmosphere (2) and diffusion into porous surfaces of the concrete. There, oxidation of  $\text{H}_2\text{S}$  with the final product of sulfuric acid ( $\text{H}_2\text{SO}_4$ ) proceeds (3), which is reacting with the cementitious phases of the concrete to form gypsum ( $\text{CaSO}_4 \cdot 2\text{H}_2\text{O}$ ) (4). Also illustrated is the pH dependency of sulfide species and possible reactions of dissolved hydrogen sulphide ions with occurring metal ions (Me).**

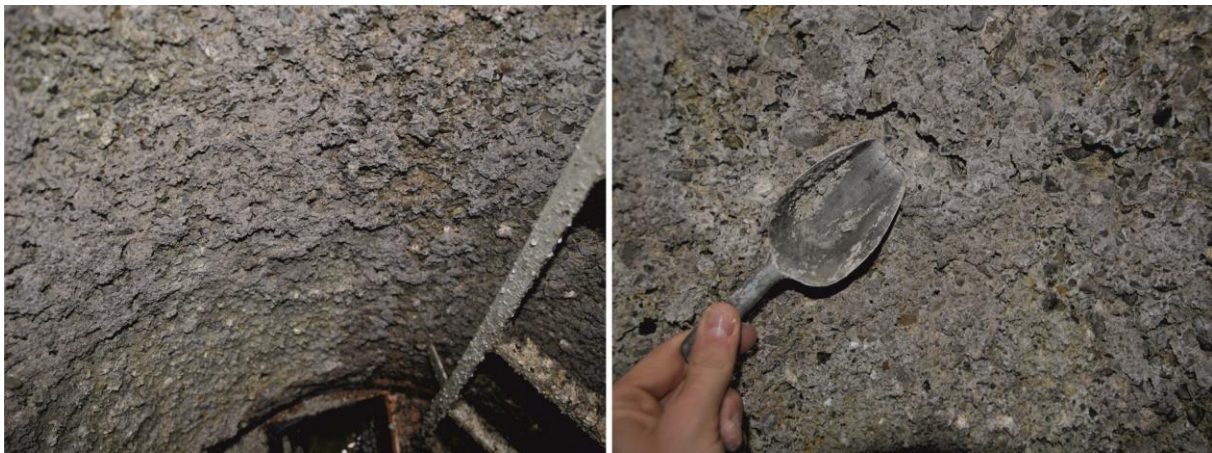
While the concrete of the storage basins show no sign of corrosion, the manholes of the gravity sewers are often strongly deteriorated. The upper few concrete layers reveal mushy rigidity and can be scratched down with bare hands. With flow distance the intensity of the corrosion decreases, resulting in non-corroded manholes at the end of the gravity sewer sections. The transported wastewater comprises mainly domestic wastewater, although one surface quarry and some minor commercial areas are also discharging into the system. Nevertheless, the quality and chemical composition of the wastewater lies within the standing orders for communal wastewater.

**Figure 4: Strong deteriorated concrete in one of the manholes of the first gravity sewer section.**

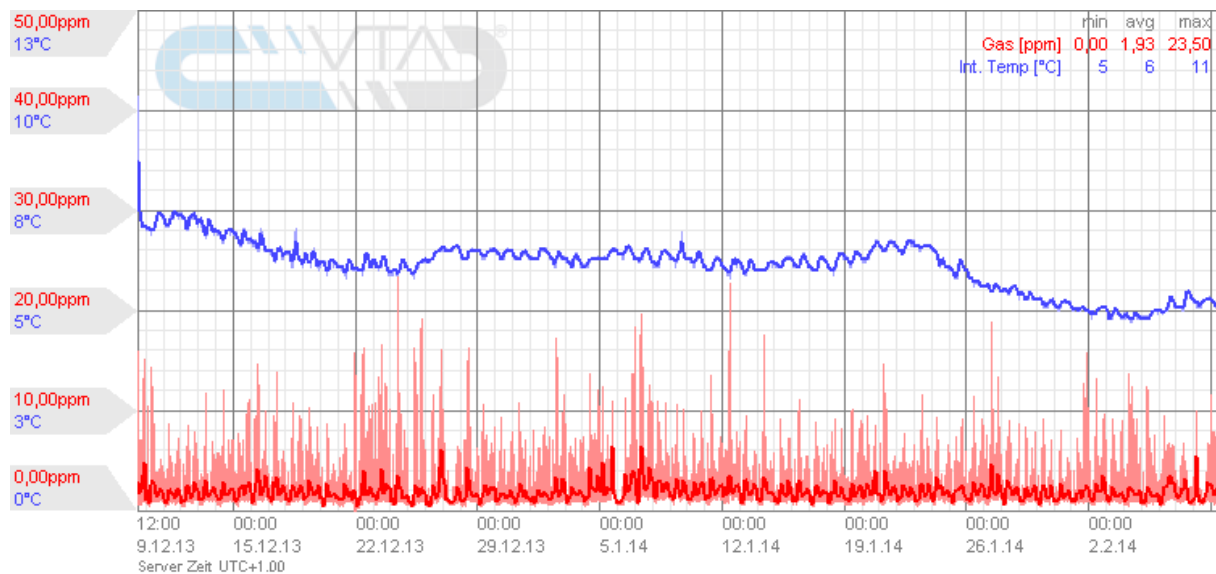
Data of long term gas measurements provided by VTA Technology GmbH, showed average concentration of 1.3 ppm H<sub>2</sub>S and a large variation between below the detection threshold and 124 ppm within the 8<sup>th</sup> manhole of GS1 during active FeCl<sub>2</sub> addition. Due to maintenance work conducted between 2.12.13 and 9.12.13 no FeCl<sub>2</sub> was added to the system. Contemporaneously, H<sub>2</sub>S values of above 440 ppm were measured. Typical H<sub>2</sub>S long term concentration variations can be seen in Figure 9. Gas measurements conducted during sampling displayed concentrations up to 84 ppm H<sub>2</sub>S within the first 8 manholes of the gravity sewer sections. With flow direction continues decrease in gaseous H<sub>2</sub>S concentrations was detected, resulting in manholes with no occurring emission. In contrast, constantly high CO<sub>2</sub> concentrations of up to 0.26 vol. % throughout the whole system were measured with no decreasing concentration trend or what so ever. Additionally, methane (CH<sub>4</sub>) concentrations of up to 4 vol. % were measured within the first 6 manholes of the GS1 and within the first of GS2.

**Figure 9:** Typical evolution of H<sub>2</sub>S concentrations within the 8<sup>th</sup> manhole of the system measured by VTA Technology GmbH.

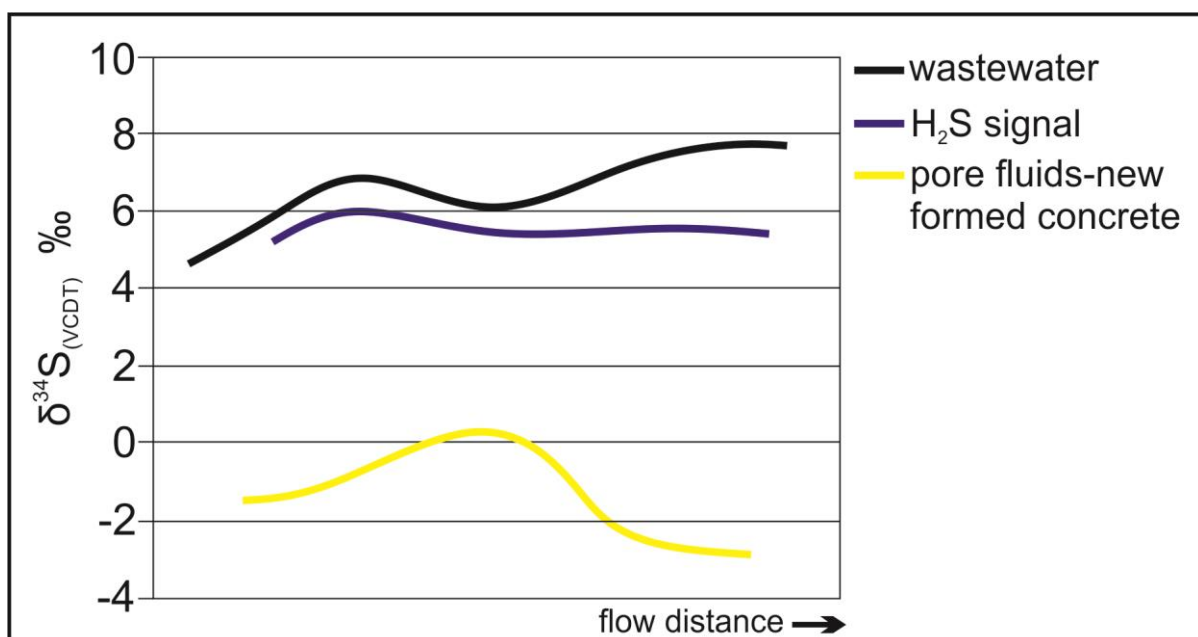
Measurements of stable sulfur isotopes clearly support bacterial activity. An isotope fractionation is obvious between samples extracted from the water phase and the newly formed gypsum. This clearly supports bacterial activity as the thriving force behind the sulfur cycle of the system. The comparatively small isotopic fractionation of 6-10 ‰ (VCDT) could be explained by almost quantitative transformation of the occurring  $\text{SO}_4^{2-}$  concentrations within great parts of the power main. Supporting evidence were low  $\text{SO}_4^{2-}$  concentrations within the upper parts of the gravity sewer. Also the production of  $\text{CH}_4$  indicated almost complete depletion of sulfate within the power main, since methanogenesis only occurs in areas where no or low sulfate concentrations are present [32]. Interestingly, no isotope fractionation of  $^{34}\text{S}$  versus  $^{32}\text{S}$  could be seen between gaseous  $\text{H}_2\text{S}$  (extracted via  $\text{ZnS}$  precipitation) and the dissolved  $\text{SO}_4^{2-}$  of the wastewater. Further research has to be carried out before a more detailed interpretation concerning the latter issue can be developed. However, isotope fractionation between  $\text{H}_2\text{S}$  and  $\text{SO}_4^{2-}$  throughout bacterial activity support the assumption of quantitative transformation of the  $\text{SO}_4^{2-}$  concentrations present within the power mains, as non-quantitative transformation would result in large kinetically controlled fractionation effects. Isotopic fractionation is displayed in Figure 14.

Figure 14: Measured  $^{34}\text{S}/^{32}\text{S}$  isotope fractionation displayed as  $\delta^{34}\text{S}$  values according to VCDT, between the dissolved  $\text{SO}_4^{2-}$  in the wastewater, the gaseous  $\text{H}_2\text{S}$ , the  $\text{SO}_4^{2-}$  in the pore fluids and the secondary formed gypsum in the deteriorated concrete with flow distance.

The results of the sulfur isotope measurements are displayed in Figure 14. The samples, precipitated as BaSO<sub>4</sub> from wastewater showed  $\delta^{34}\text{S}$  values of the dissolved sulfate ranging around  $6 \pm 3 \text{ ‰}$  (VCDT). With flow distance, enrichment in heavy versus light S isotopes could be detected. Signals of interstitial fluids, extracted from the pore volume of the deteriorated concrete displayed significant lighter signatures from  $-2 \pm 2 \text{ ‰}$ . Accordingly,  $\delta^{34}\text{S}$  values measured within the corroded concrete showed values of  $-2 \pm 2 \text{ ‰}$  as well. Interestingly, isotopic signatures, derived from ZnS, which refers to the gaseous H<sub>2</sub>S, comprised  $\delta^{34}\text{S}$  values similar to the  $\delta^{34}\text{S}$  values caught within the wastewater between 7 and 8 ‰.

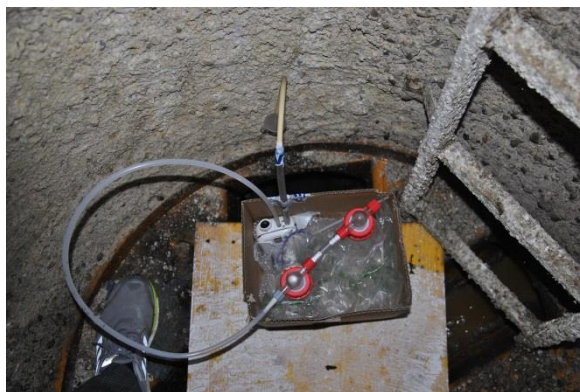
Gas samples of the sewer atmosphere were taken using a gas sampling tubes. The isotopic signature of carbon was directly measured. The stable sulfur isotope ratios (<sup>34</sup>S/<sup>32</sup>S) were analyzed by combustion of BaSO<sub>4</sub>- or ZnS- using a Thermo Finnigan 253 mass spectrometer [5]. The δ<sup>34</sup>S values, gained from BaSO<sub>4</sub> represent samples extracted from the wastewater and concrete. The δ<sup>34</sup>S values obtained from ZnS reflect the signature of gaseous hydrogen sulfide (H<sub>2</sub>S), which was captured by a 5% zinc acetate solution and consequently precipitated as ZnS. Results are given in δ<sup>34</sup>S-notations in ‰ relative to the Vienna-Canyon Diablo Troilite (V-CDT) standard. Figure 16 shows one of the gas traps in which H<sub>2</sub>S was precipitated as ZnS.

**Figure 16:** Gas trap in a corroded manhole. This trap consists of two “Woulf’sche bottles” that contain 5% Zn-acetate solutions and an air pump. Here, H<sub>2</sub>S reacts with the Zn-acetate to form solid ZnS.
